■ Solenoid Assembly Test: Functional Verification of Air Conditioning Solenoid Assembly

AN178

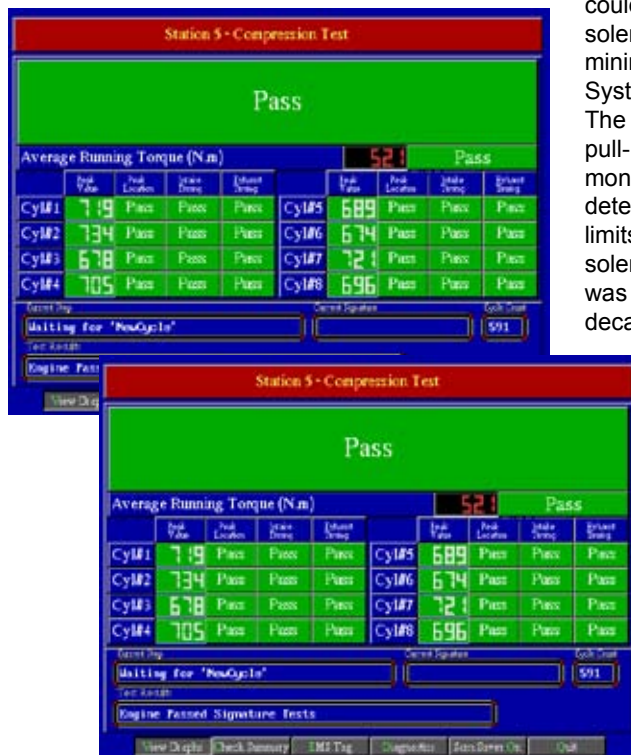
InSpeXion® Solenoid Assembly Screens showing Test Diagnostics.

could be issued to the operator. Using current and voltage, the solenoid coil resistance was measured and compared against a minimum and maximum value. The Sciometric Test and Analysis System was configured to control a programmable power supply. The voltage was then ramped up and down so that the solenoid pull-in and drop-out voltage could be determined. Flow was monitored by energizing each solenoid and using a flow-meter to determine if the amount of air allowed to flow met pre-determined limits. Finally, leakage was monitored by creating a vacuum in the solenoid assembly and sealing it. The decay in vacuum over time was then compared against an acceptable maximum pressure decay rate.
